Manhole Inspection Summary

Manhole # S37AA_013MH

Location Address: **620 fallsway**

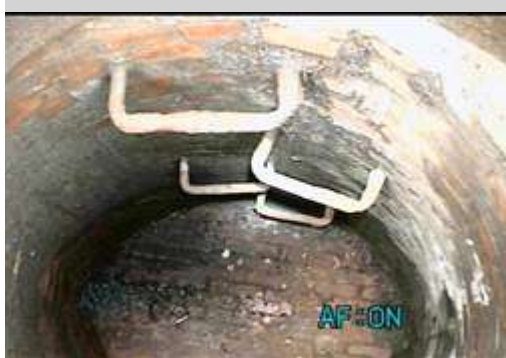
Defect 3

Count: **4** Missing: **0** ☒ **Corroded**

corr steps

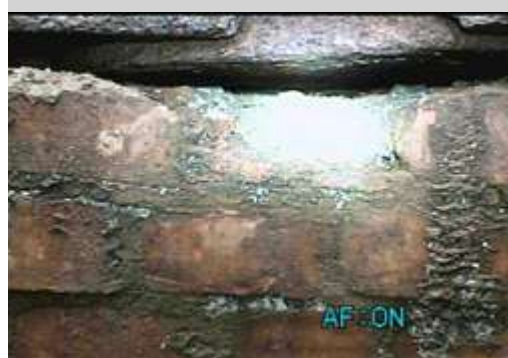
Defect 2

Condition: ☐ Sound ☐ Cracked ☐ Root Intrusion ☒ **Loose Brick** ☒ **Deteriorated**

chimney loose bricks, frame adj

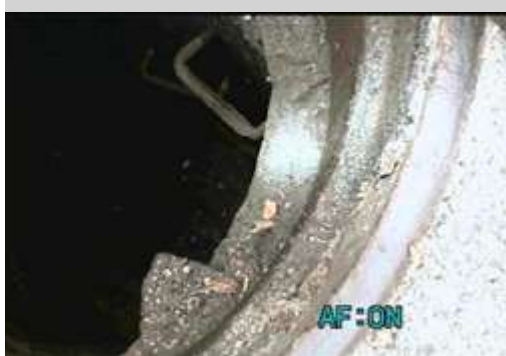
Defect 1

Offset: **2** (in.)

offset

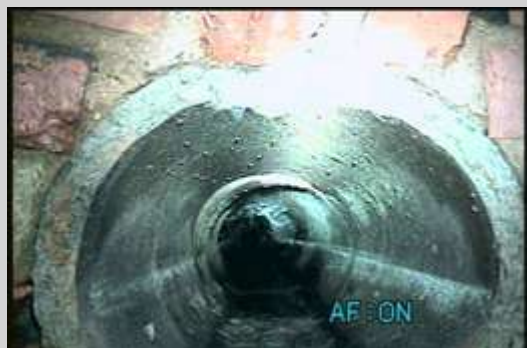
12 O'Clock Outflow

8 in. Circular Gravity Sewer
Pipe Out @ 12 O'Clock

Pipe Material: **Clay** ☐ Pipe Lined

Invert Depth: **7.25** (ft.) Flow Characteristics: **None**

Deposits: ☒ None ☐ Mud ☐ Sludge ☐ Debris ☐ Grease

Infiltration: **None** Pipe Seal Cond: **Unknown**
